Troubleshooting Guide

Possible causes and remedies
for ten possible problem
cases, which can occur during
a film coating process.

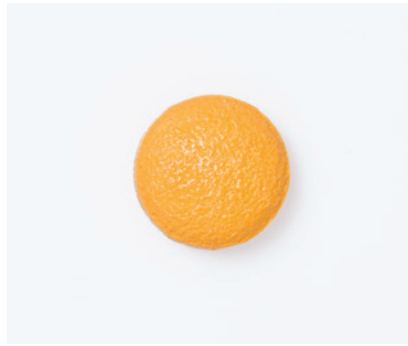
Orange Peel/Roughness

Rough or uneven surface of the tablets

- Distance between nozzle and tablet bed is incorrect
- Spray angle is wrong
- Spray drying
- Sedimentation of the dispersion
- Viscosity/solid content is too high
- Core properties are inadequate (high friability)
- Atomizing air pressure incorrect – too high or too low (AA)

- Increasing the spray rate
- Decreasing the drying capacity
- Reducing the atomizing air pressure
- Decreasing the viscosity
- Optimizing the distance between nozzle and tablet bed

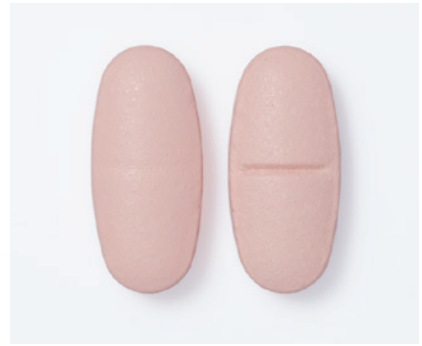
Logo Bridging

Filling of the logo or the break line

- Viscosity is too high
- Plasticizer content is too low
- Spray rate is too high
- Atomizing air pressure is not right (too low/high)

- Decreasing the viscosity
- Increasing the plasticizer content
- Reducing the spray rate
- Adjusting the spray pressure (increase or decrease)

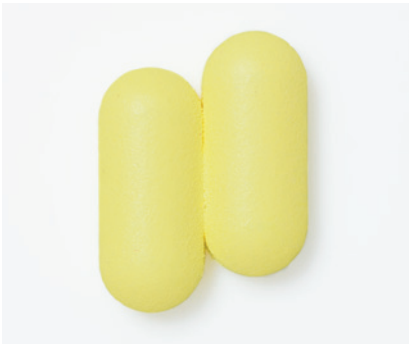
Twinning

Two or more tablets stick together

- Overhumidification
- Process air volume is too low
- Tablet shape "planar" is not suitable

- Reducing spray rate
- Increasing the drying capacity
- Optimizing the form of the tablets to "biconvex"
- Using release agents in the formulation

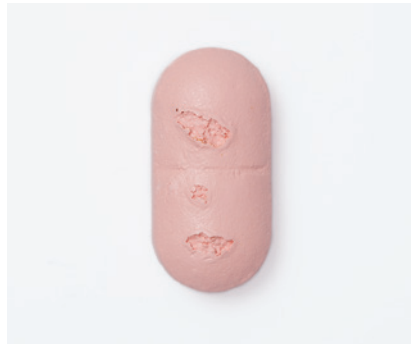
Sticking and ripping off coating

Tablets rip off the coating from each other

- Pan speed is too low
- Air temperature is too low
- Process air volume is too low
- Spray rate is too high
- Process is too damp

- Increasing the pan speed
- Increasing the inlet air temperature
- Increasing the process air volume
- Reducing the spray rate

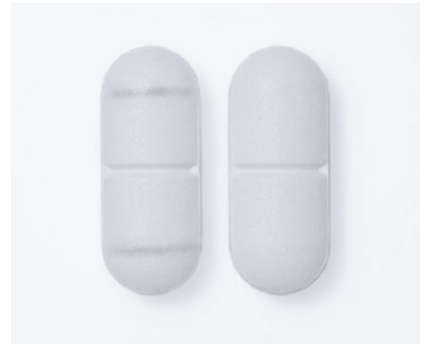
Scuffing

Gray layer forms on the tablet surface

- Titanium dioxide quantity is too high
- Interaction between drum wall and coating

- Reducing the titanium dioxide
- Spraying the drum prior to the trial

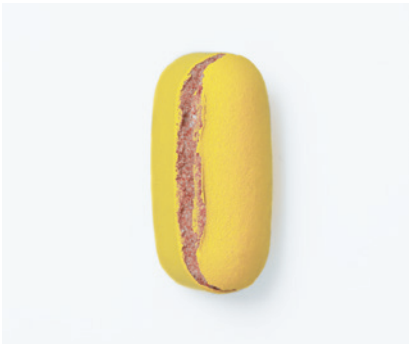
Capping

Detachment of the film surface

-
- Hygroscopic core
 - Disintegrants are used

-
- Using a subcoat
 - Optimizing process parameters

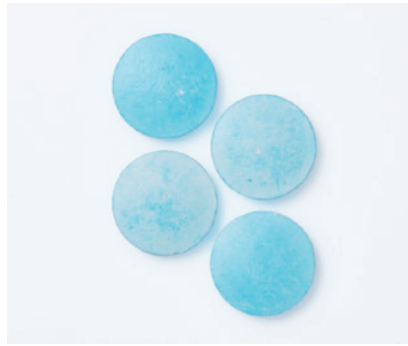
Colour variation I

Batch has heterogeneous colour

-
- Coverage properties of the coating are insufficient
 - Solid content of the suspension is too high
 - Weight gain level is too low
 - Batch quantity is too low

-
- Increasing the coverage properties of the coating (more pigments)
 - Reducing the solid content
 - Increasing the weight gain level

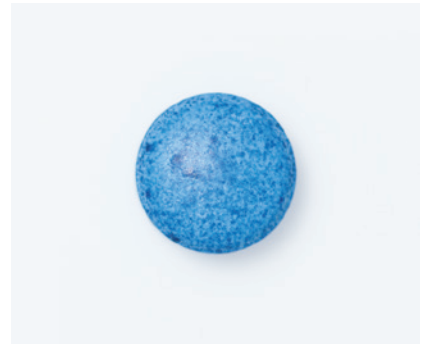
Colour variation II

Individual tablets have heterogeneous colour

-
- Application rate is too low
 - API interacts with the coating material
 - Low opacity
 - Active ingredients diffuse from the core
 - Overhumidification

-
- Increasing the weight gain
 - Adapting the formula/changing the pigments
 - Increasing the coverage properties of the coating formulation
 - Using a subcoat
 - Increasing the tablet bed temperature

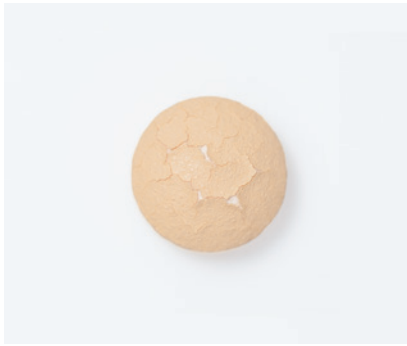
Peeling

Spalling of the film – possible cracking of the coating

-
- Tablet is swelling
 - Plasticizer content in coating suspension is too low
 - Tablet is too wet
 - Tablet hardness is too low
 - Tablet is outgassing

-
- Using a subcoat
 - Increasing the plasticizer content
 - Spraying with drier conditions
 - Increasing the film forming polymer

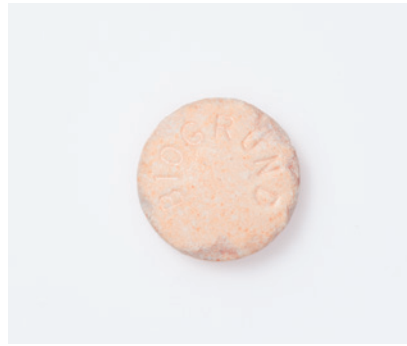
Friability

Tablet mass reduced due to abrasion

-
- Mechanical stress
 - Tablets are too soft
 - Tablets are too damp
 - Pan speed is too high

-
- Reducing the pan speed
 - Optimizing the core formulation
 - Spraying with drier conditions
 - Using the interval “jog mode” while heating cores
