# Troubleshooting Guide

Possible causes and remedies  
for ten possible problem  
cases, which can occur during  
a film coating process.

# Every coating process is a challenge

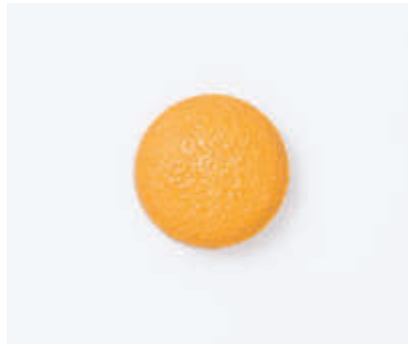
## Orange Peel/Roughness

**Rough or uneven surface of the tablets**

- Distance between nozzle and tablet bed is incorrect
- Spray angle is wrong
- Spray drying
- Sedimentation of the dispersion
- Viscosity/solid content is too high
- Core properties are inadequate (high friability)
- Atomizing air pressure incorrect – too high or too low (AA)

- Increasing the spray rate
- Decreasing the drying capacity
- Reducing the atomizing air pressure
- Decreasing the viscosity
- Optimizing the distance between nozzle and tablet bed

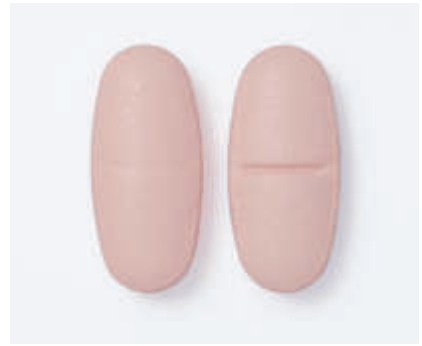
## Logo Bridging

**Filling of the logo or the break line**

- Viscosity is too high
- Plasticizer content is too low
- Spray rate is too high
- Atomizing air pressure is not right (too low/high)

- Decreasing the viscosity
- Increasing the plasticizer content
- Reducing the spray rate
- Adjusting the spray pressure (increase or decrease)

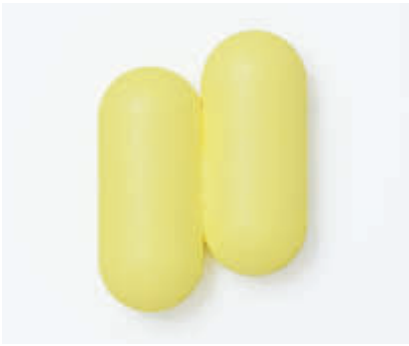
## Twinning

Two or more tablets stick together

- Overhumidification
- Process air volume is too low
- Tablet shape “planar” is not suitable

- Reducing spray rate
- Increasing the drying capacity
- Optimizing the form of the tablets to “biconvex”
- Using release agents in the formulation

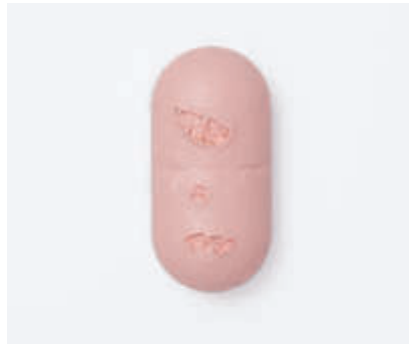
## Sticking and ripping off coating

Tablets rip off the coating from each other

- Pan speed is too low
- Air temperature is too low
- Process air volume is too low
- Spray rate is too high
- Process is too damp

- Increasing the pan speed
- Increasing the inlet air temperature
- Increasing the process air volume
- Reducing the spray rate

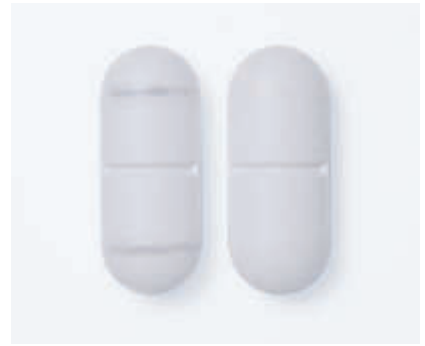
## Scuffing

Gray layer forms on the tablet surface

- Titanium dioxide quantity is too high
- Interaction between drum wall and coating

- Reducing the titanium dioxide
- Spraying the drum prior to the trial

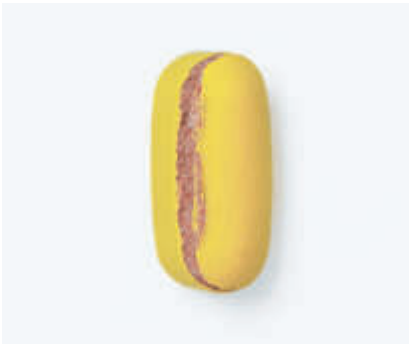
## Capping

Detachment of the film surface

- 
- Hygroscopic core
  - Disintegrants are used

- 
- Using a subcoat
  - Optimizing process parameters

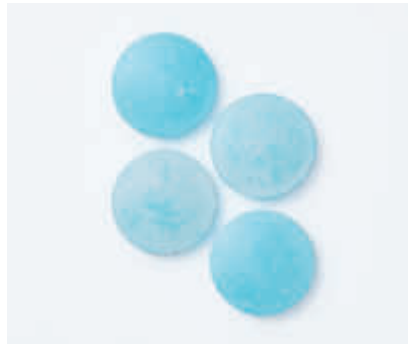
## Color variation I

Batch has heterogeneous color

- 
- Coverage properties of the coating are insufficient
  - Solid content of the suspension is too high
  - Weight gain level is too low
  - Batch quantity is too low

- 
- Increasing the coverage properties of the coating (more pigments)
  - Reducing the solid content
  - Increasing the weight gain level

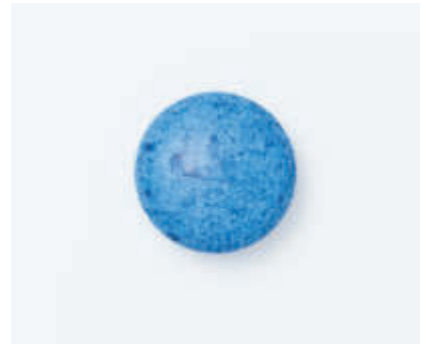
## Color variation II

Individual tablets have heterogeneous color

- 
- Application rate is too low
  - API interacts with the coating material
  - Low opacity
  - Active ingredients diffuse from the core
  - Overhumidification

- 
- Increasing the weight gain
  - Adapting the formula/changing the pigments
  - Increasing the coverage properties of the coating formulation
  - Using a subcoat
  - Increasing the tablet bed temperature

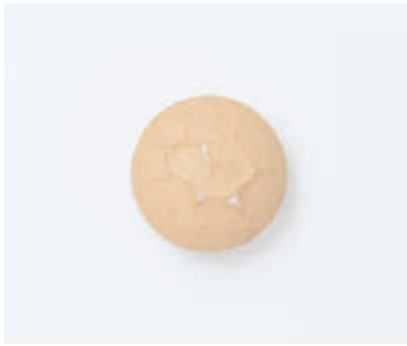
## Peeling

**Spalling of the film – possible cracking of the coating**

- 
- Tablet is swelling
  - Plasticizer content in coating suspension is too low
  - Tablet is too wet
  - Tablet hardness is too low
  - Tablet is outgassing

- 
- Using a subcoat
  - Increasing the plasticizer content
  - Spraying with drier conditions
  - Increasing the film forming polymer

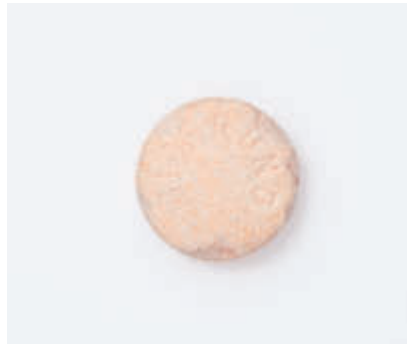
## Friability

**Tablet mass reduced due to abrasion**

- 
- Mechanical stress
  - Tablets are too soft
  - Tablets are too damp
  - Pan speed is too high

- 
- Reducing the pan speed
  - Optimizing the core formulation
  - Spraying with drier conditions
  - Using the interval “jog mode” while heating cores
