Troubleshooting Guide

Possible causes and remedies
for ten possible problem
cases, which can occur during
a film coating process.

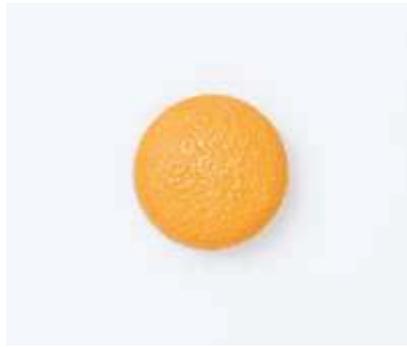
Orange Peel/Roughness

Rough or uneven surface of the tablets

- Distance between nozzle and tablet bed is incorrect
- Spray angle is wrong
- Spray drying
- Sedimentation of the dispersion
- Viscosity/solid content is too high
- Core properties are inadequate (high friability)
- Atomizing air pressure incorrect – too high or too low (AA)

- Increasing the spray rate
- Decreasing the drying capacity
- Reducing the atomizing air pressure
- Decreasing the viscosity
- Optimizing the distance between nozzle and tablet bed

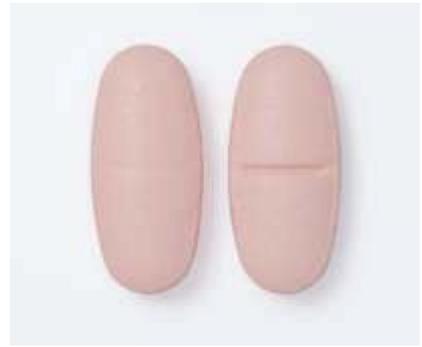
Logo Bridging

Filling of the logo or the break line

- Viscosity is too high
- Plasticizer content is too low
- Spray rate is too high
- Atomizing air pressure is not right (too low/high)

- Decreasing the viscosity
- Increasing the plasticizer content
- Reducing the spray rate
- Adjusting the spray pressure (increase or decrease)

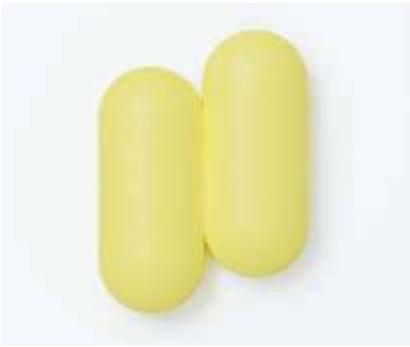
Twinning

Two or more tablets stick together

- Overhumidification
- Process air volume is too low
- Tablet shape “planar” is not suitable

- Reducing spray rate
- Increasing the drying capacity
- Optimizing the form of the tablets to “biconvex”
- Using release agents in the formulation

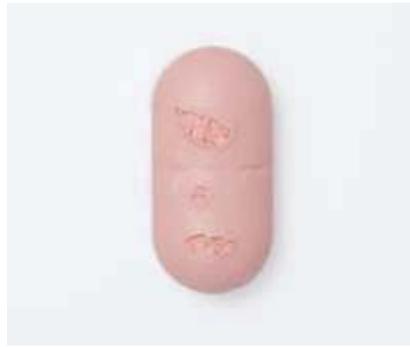
Sticking and ripping off coating

Tablets rip off the coating from each other

- Pan speed is too low
- Air temperature is too low
- Process air volume is too low
- Spray rate is too high
- Process is too damp

- Increasing the pan speed
- Increasing the inlet air temperature
- Increasing the process air volume
- Reducing the spray rate

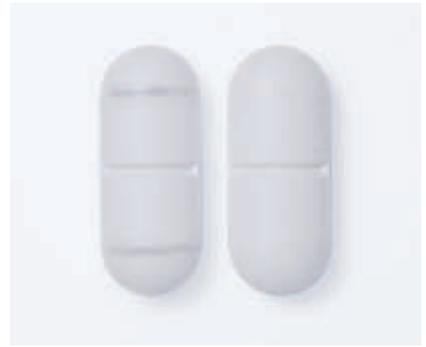
Scuffing

Gray layer forms on the tablet surface

- Titanium dioxide quantity is too high
- Interaction between drum wall and coating

- Reducing the titanium dioxide
- Spraying the drum prior to the trial

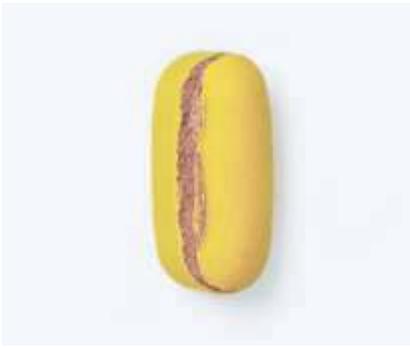
Capping

Detachment of the film surface

-
- Hygroscopic core
 - Disintegrants are used

-
- Using a subcoat
 - Optimizing process parameters

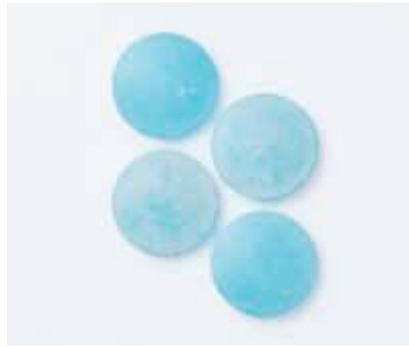
Color variation I

Batch has heterogeneous color

-
- Coverage properties of the coating are insufficient
 - Solid content of the suspension is too high
 - Weight gain level is too low
 - Batch quantity is too low

-
- Increasing the coverage properties of the coating (more pigments)
 - Reducing the solid content
 - Increasing the weight gain level

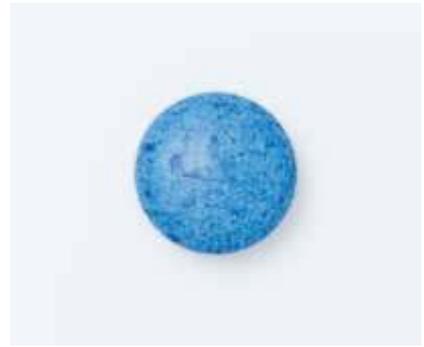
Color variation II

Individual tablets have heterogeneous color

-
- Application rate is too low
 - API interacts with the coating material
 - Low opacity
 - Active ingredients diffuse from the core
 - Overhumidification

-
- Increasing the weight gain
 - Adapting the formula/changing the pigments
 - Increasing the coverage properties of the coating formulation
 - Using a subcoat
 - Increasing the tablet bed temperature

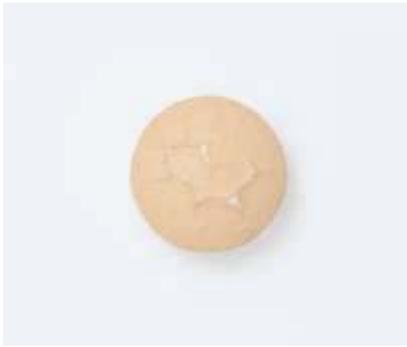
Peeling

Spalling of the film – possible cracking of the coating

-
- Tablet is swelling
 - Plasticizer content in coating suspension is too low
 - Tablet is too wet
 - Tablet hardness is too low
 - Tablet is outgassing

-
- Using a subcoat
 - Increasing the plasticizer content
 - Spraying with drier conditions
 - Increasing the film forming polymer

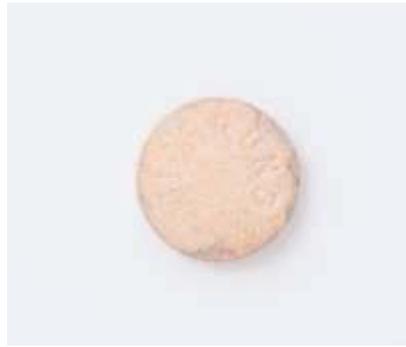
Friability

Tablet mass reduced due to abrasion

-
- Mechanical stress
 - Tablets are too soft
 - Tablets are too damp
 - Pan speed is too high

-
- Reducing the pan speed
 - Optimizing the core formulation
 - Spraying with drier conditions
 - Using the interval “jog mode” while heating cores
